# **Hampden Road Bridge, Murrumbidgee River, Wagga Wagga, NSW Demolition of Bridge, 20 August 2014**

**Paper prepared by Owen Peake, for Engineering Heritage Australia**

**10 March 2014**

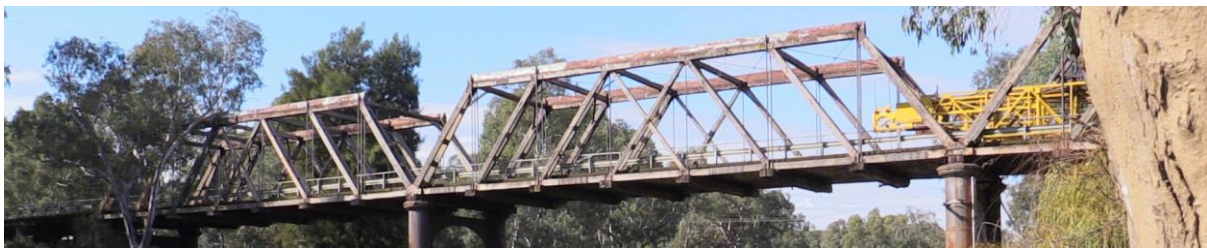
Hampden Bridge before the demolition in May 2014. *Image: Wagga Wagga City Council web site.*

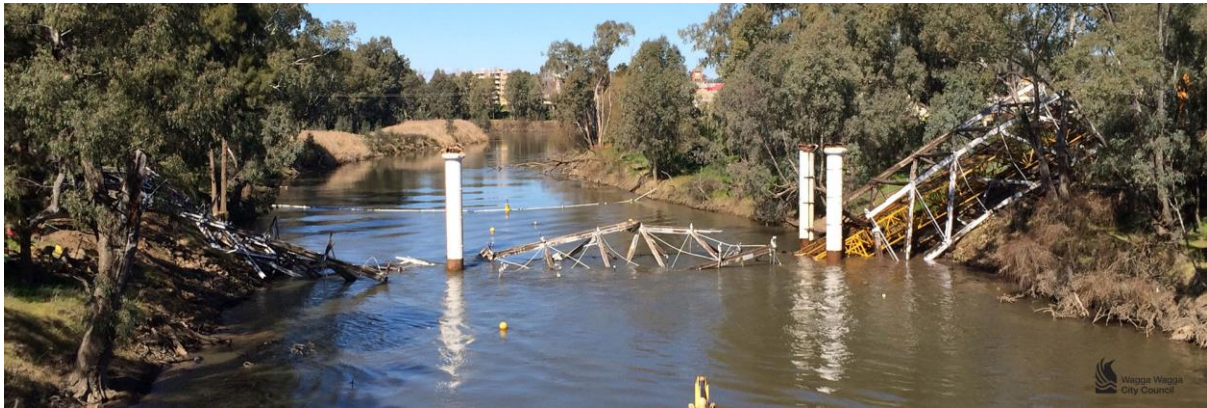
The remains of the bridge immediately after the demolition. Image: Wagga Wagga City Council web site.

**The bridge was demolished on 20 August 2014 by the use of explosive charges to remove the centre span then by the use of heavy earthmoving equipment on the rivers banks to destabilise and collapse the spans adjacent to the abutments.**

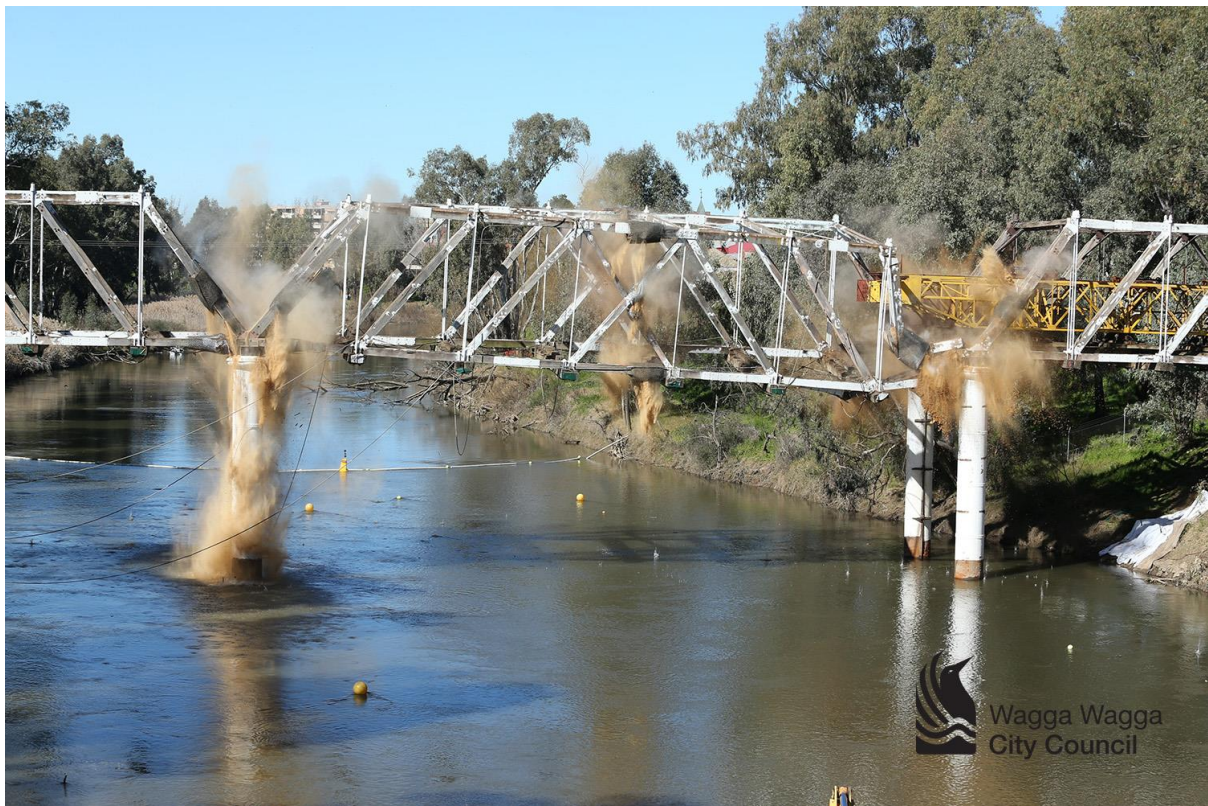
**The centre of the span shortly after detonation of charges. Image: Wagga Wagga City Council web site.**

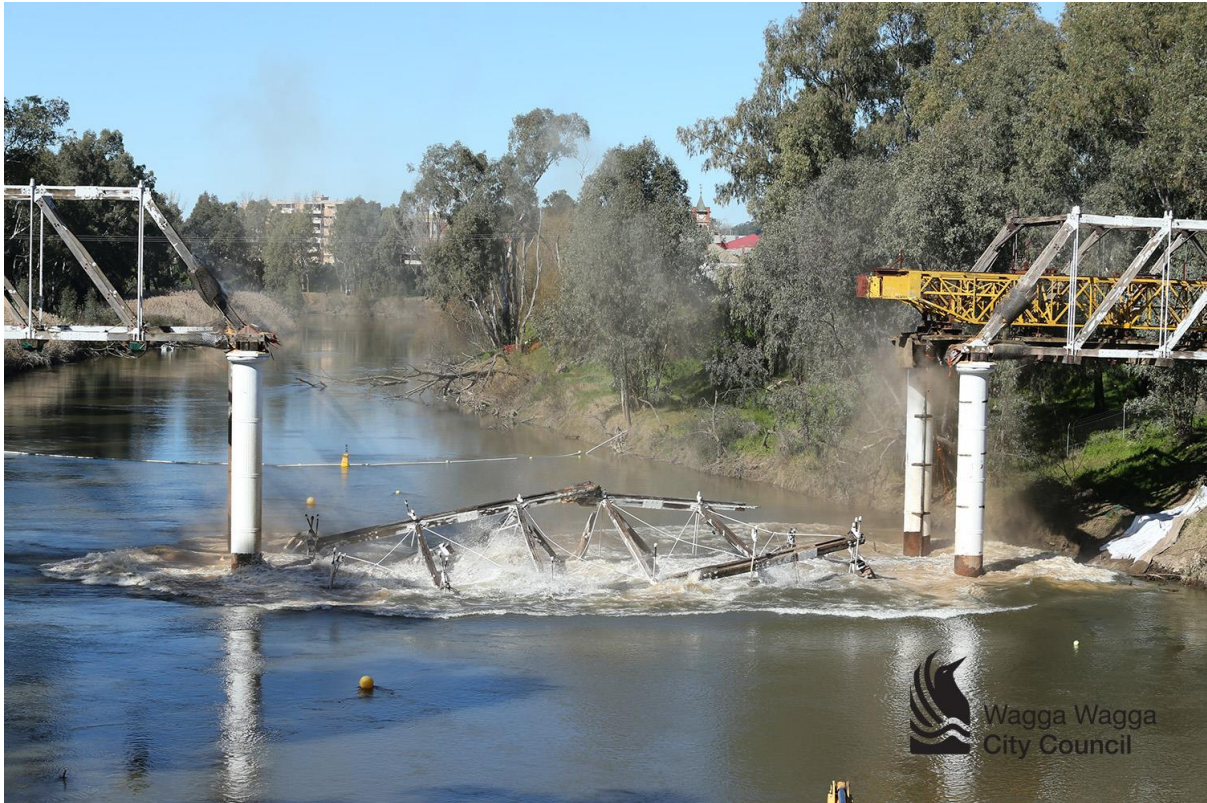
The centre of the span shortly after the span settled in the river. *Image: Wagga Wagga City Council web site.*
